# **Inspection Report**

Permit Number:	C0070012
Inspection Type:	PARTIAL
Inspection Date:	Tuesday, March 15, 2005
Start Date/Time:	3/15/2005 9:00:00 AM
End Date/Time:	3/15/2005 12:30:00 PM
Last Inspection:	Wednesday, February 23, 2005

Permitee: NEVADA ELECTRIC INVESTMENT CO
Operator: NEVADA ELECTRIC INVESTMENT CO
Site: WELLINGTON PREPARATION PLANT

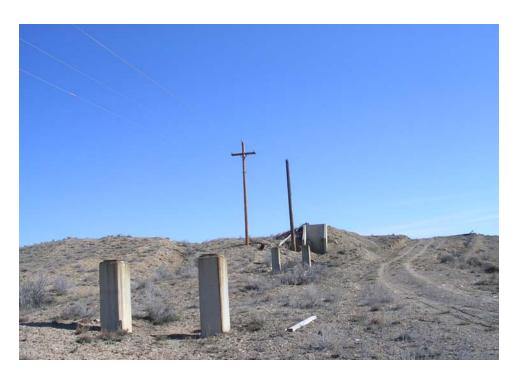
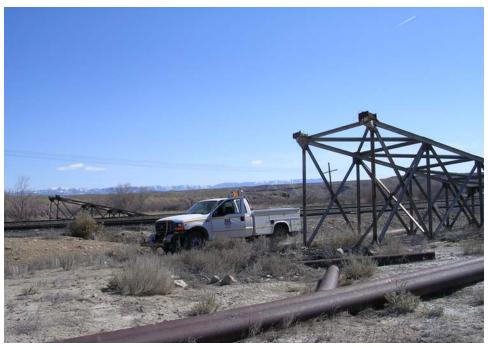
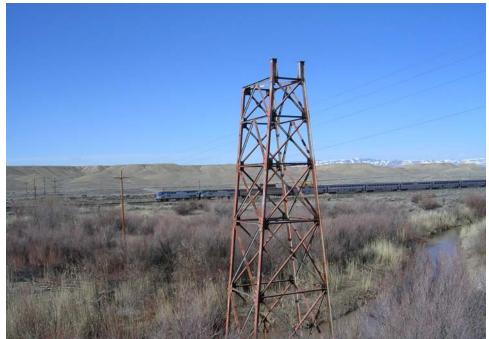
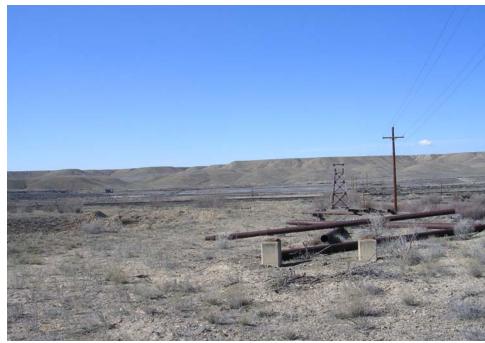
Reclamation of 11 pipeline support structures (75 ft apart) as described on pp. 6 - 10 of Section 5.40 was approved by the Division on Feb 28, 2002 AM02A Future Reclamation (Task #24). Structures were connected by horizontal cross beams that extended across the railroad tracks, bottomlands of the property and the Price River (Figures 5.40-1 and 5.40-2.) Structures were set in concrete footings at the surface. Approval of this activity indicated that reclamation would be conducted in winter when the ground was frozen, to protect in place topsoil; surface coal fines (where present) would be removed: and concrete would be removed to two feet below the surface. Disturbed areas would be reseeded with riparian mix in Sec 3.41 and also shown in Table 5.40-1. At the time of this inspection, several towers or parts of towers could be seen on the surface along with several 40 ft lengths of steel pipe. The concrete tower foundations were still in place. Mr. Collins explained that the contractor who was removing the structures did not return to complete the job after a fire was started by a welding torch in August 2002 during the work. This steel must be removed from the site, so that the reclamation work can be completed. See attached photos of structures.

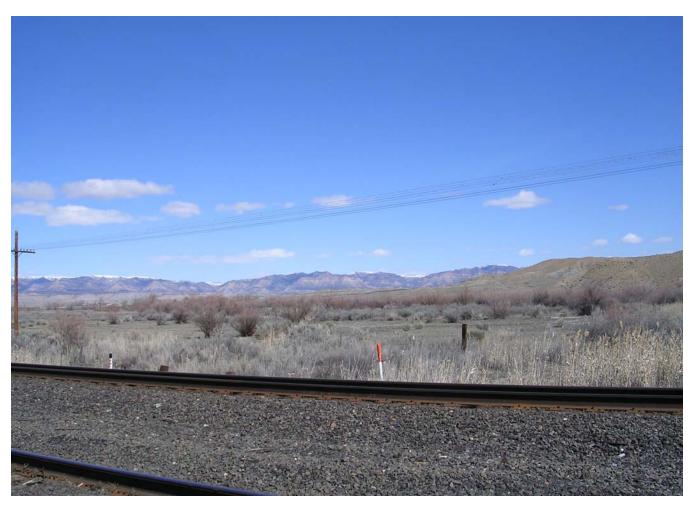
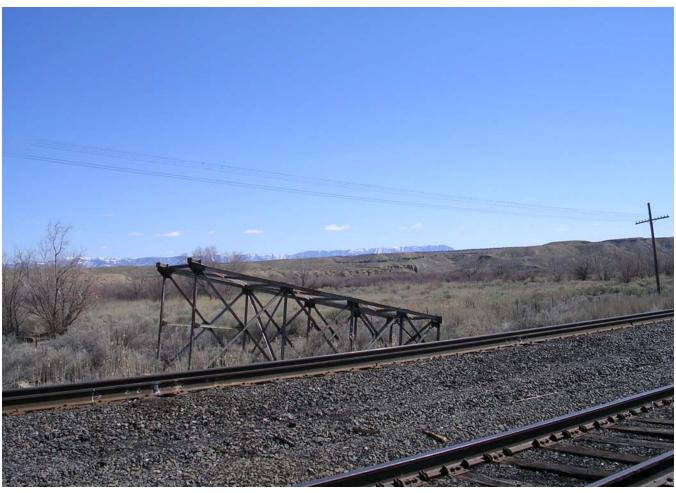
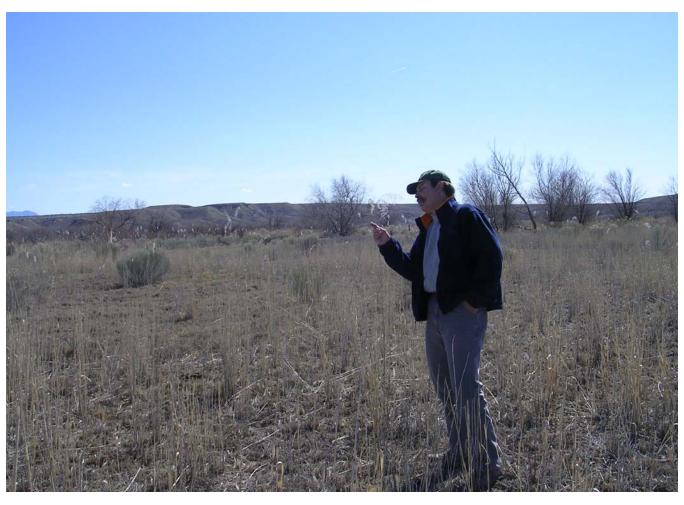
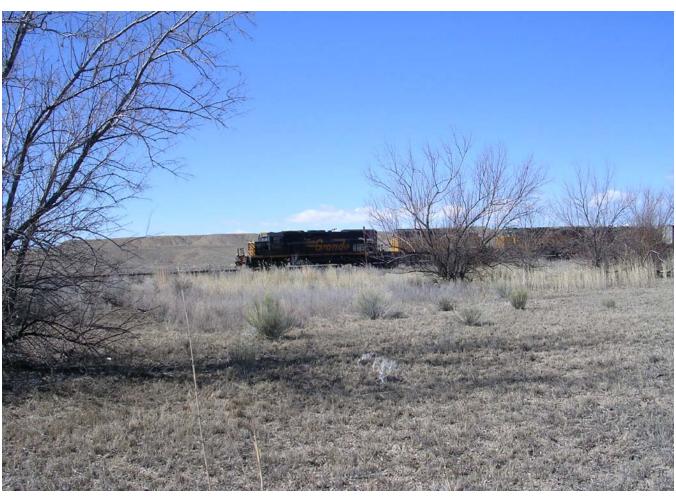
The riparian area that was burned (during tower structure removal, August 2002) has recovered without any seeding by the Permittee. Predominant plants growing now in the former burn area are canary reed grass, greasewood, rabbitbrush, saltgrass and Russian olive. The area is immediately east of the railroad tracks within the permit area. A similar area to the north of the burned area has similar vegetation, except for a conspicuous absence of canary reed grass. The effects of prescribed burning on removing halogeton seed or stimulating desireable species and the application of this tool for reclamation of the Wellington site was discussed. See attached photos of regrowth.
